<b>Area:</b> Geraldton	<b>Place Number:</b> 84	<b>Category:</b> 4
<b>Assessment Date:</b> 25/10/1996	<b>Last Revision Date:</b> 27/10/2009	
<b>HCWA Number:</b> 13338	<b>Asset ID:</b> MCH126488

<b>Name:</b>	House
<b>Other Names:</b>	15 Conway Street
<b>Type of Place:</b>	House
<b>Address:</b>	15 Conway Street
<b>Suburb:</b>	Beachlands

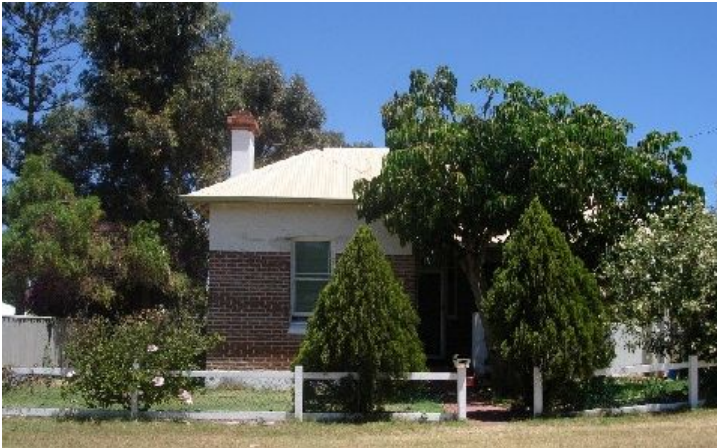
View to house partly obscured by vegetation.

<b>Walls:</b>	Brick	<b>Roof:</b>	Corrugated Iron
<b>Condition:</b>	Good	<b>Integrity:</b>	
<b>Original fabric:</b>			
<b>Modifications:</b>	Partial verandah infill

<b>Management Category:</b>	4
<b>Level of Significance:</b>	SOME SIGNIFICANCE: Contributes to the heritage and/or historical development of the locality.
<b>Management Recommendation:</b>	Conservation of the place is desirable. Any proposed change to the place should be in sympathy with the heritage values of the place.

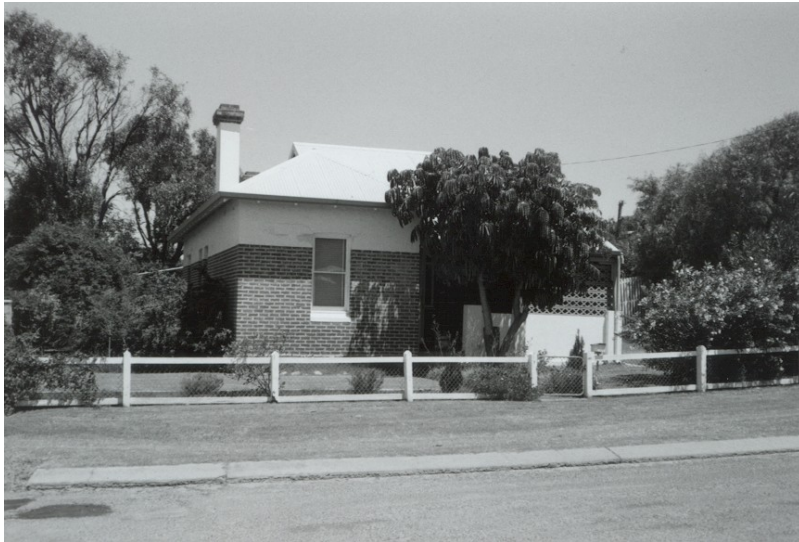
Tall chimney punctuates the roof scape.
