Area: Geraldton	Place Number: 354	Category: 3
Assessment Date: 24/10/1996	Last Revision Date: 11/03/2010	
HCWA Number: 13746	Asset ID: MCH126861

Name:	House
Other Names:	100-102 Sanford Street
Type of Place:	House
Address:	100-102 Sanford Street
Suburb:	Geraldton

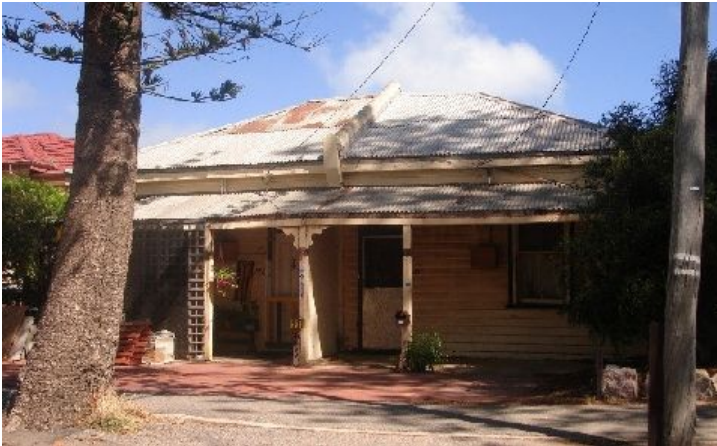
Decorative verandah brackets.

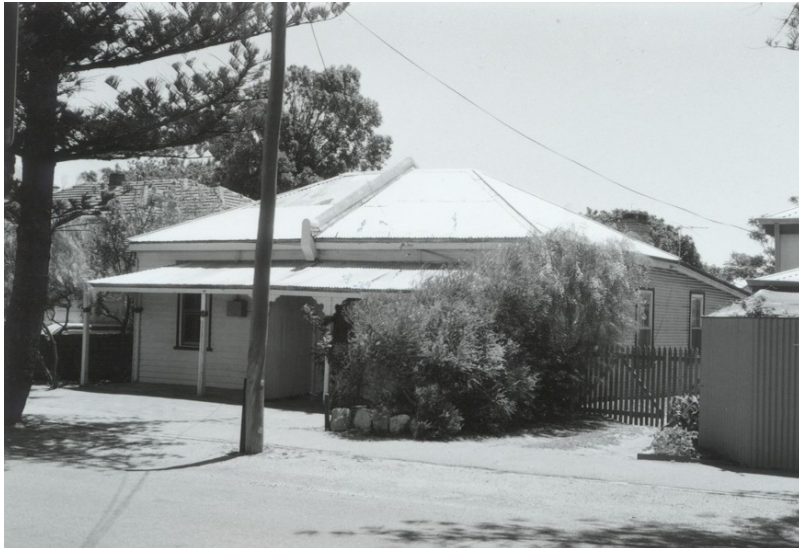
Front facade of the two houses.
