<b>Area:</b> Geraldton	<b>Place Number:</b> 360	<b>Category:</b> 2
<b>Assessment Date:</b> 24/10/1996	<b>Last Revision Date:</b> 11/03/2010	
<b>HCWA Number:</b> 13753	<b>Asset ID:</b> MCH126498

<b>Name:</b>	House
<b>Other Names:</b>	142-144 Sanford Street
<b>Type of Place:</b>	House
<b>Address:</b>	142-144 Sanford Street
<b>Suburb:</b>	Geraldton

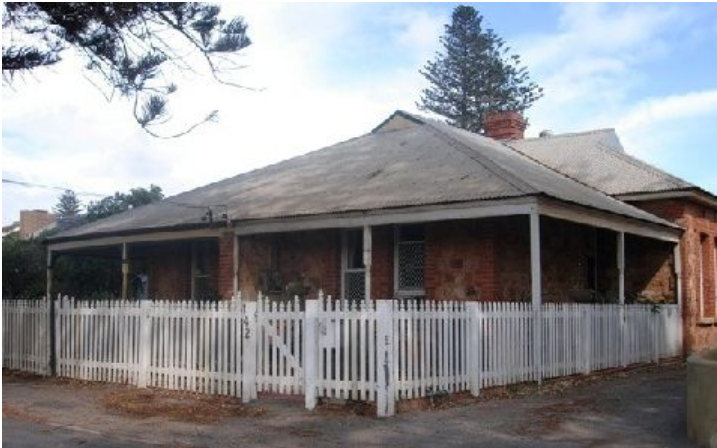
Front facade showing brick quoining detail.

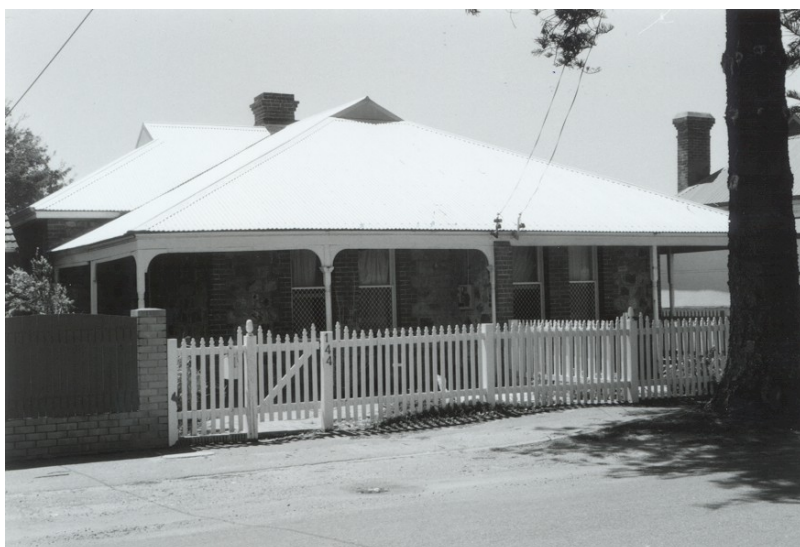
Corbelled brick chimney at centre of roof.
