Area: Geraldton	Place Number: 13	Category: 3
Assessment Date: 15/10/1996	Last Revision Date: 06/07/2009	
HCWA Number: 13205	Asset ID: MCH126922

Name:	House
Other Names:	173 Augustus Street
Type of Place:	House
Address:	173 Augustus Street
Suburb:	Beachlands

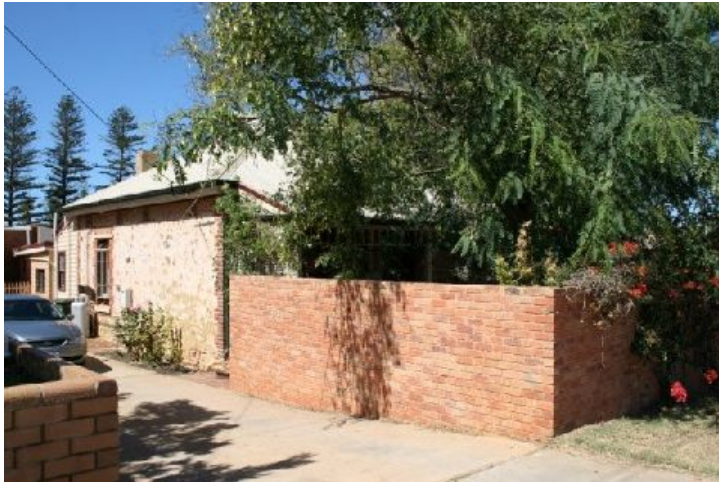
21/01/2008

Front elevation largely obscured by high brick wall and vegetation.

Walls:	Stone/Brick	Roof:	Corrugated Iron
Condition:	Good	Integrity:	
Original fabric:	Stone walls		
Modifications:	Fibro and brick addition to rear

A corrugated iron gambrel roof to the main house extends to cover the front (north) verandah. There is a brick chimney to the south west. To the rear, a lean-to roof covers a fibro clad addition. Beyond, is a brick addition with a skillion roof. The front verandah is supported on timber posts on brick bases. The decorative timber frieze below the front verandah beam features small turned balusters. The ends of the verandah have lattice infill. The front of the house features coursed pointed stonework with red brick quoining to openings and corners and arched brickwork above the windows. The sides of the house are random stonework. The windows are timber framed single pane and double hung. A tall brick wall surrounds the front of the house and largely obscures the view to the building from the street.

Management Category:	3
Level of Significance:	MODERATE SIGNIFICANCE: Important to the heritage of the locality.
Management Recommendation:	Conservation of the place is recommended. Any proposed change to the place should not unduly impact on the heritage values of the place and should retain significant fabric wherever feasible.

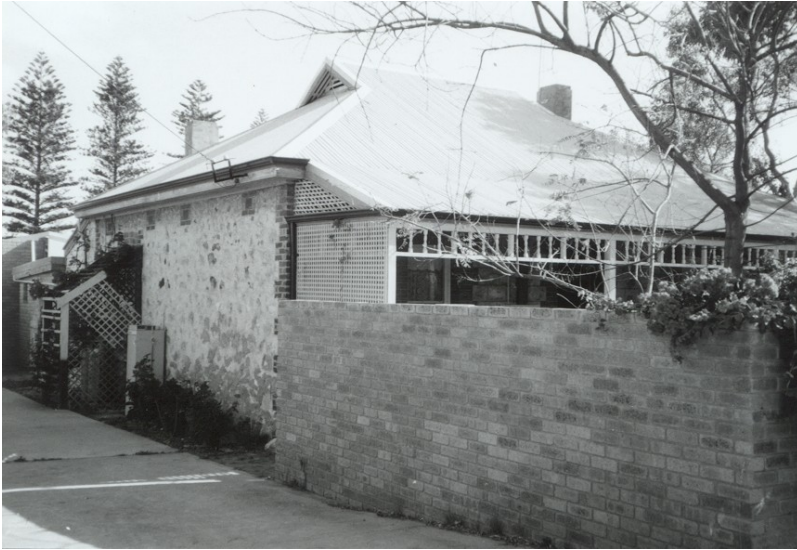
Photo Description:
15/10/1996
Suba & Grundy
Stone walls evident.
