Area: Geraldton	Place Number: 178	Category: 2
Assessment Date: 14/10/1996	Last Revision Date: 19/11/2009	
HCWA Number: 13275	Asset ID: MCH126846

Name:	Office
Other Names:	18 Francis Street
Type of Place:	Office
Address:	18 Francis Street
Suburb:	Geraldton

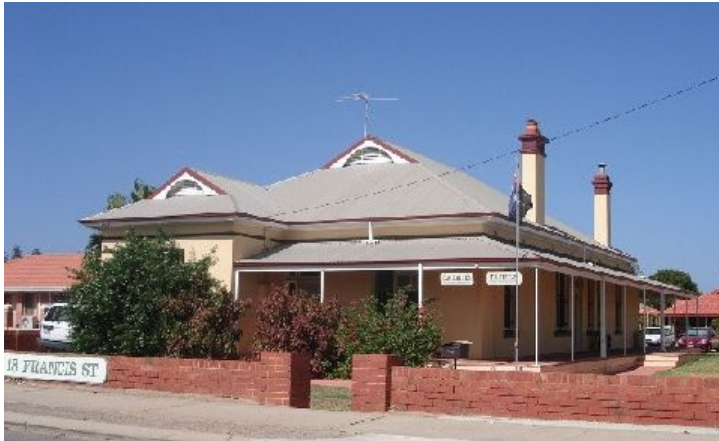
Photo Description:

Large former house set in spacious grounds.

This large rendered masonry house has a corrugated iron gambrel roof with arched bargeboards to the two timber louvered gables. A smaller separate gambrel roof to the south east replicates the main roof. A separate hipped verandah roof to the north and east elevation is supported on metal verandah posts. There are two tall rendered masonry chimneys (formerly three) with exposed brick corbelling and terracotta chimney pots to the north east and north west of the main roof. Windows are timber framed and double hung with a french door to the east verandah.

Management Category:	2
Level of Significance:	CONSIDERABLE SIGNIFICANCE: Very important to the heritage of the locality.
Management Recommendation:	Conservation of the place is highly recommended. Any proposed change should not unduly impact on the heritage values of the place and should retain significant fabric wherever feasible.

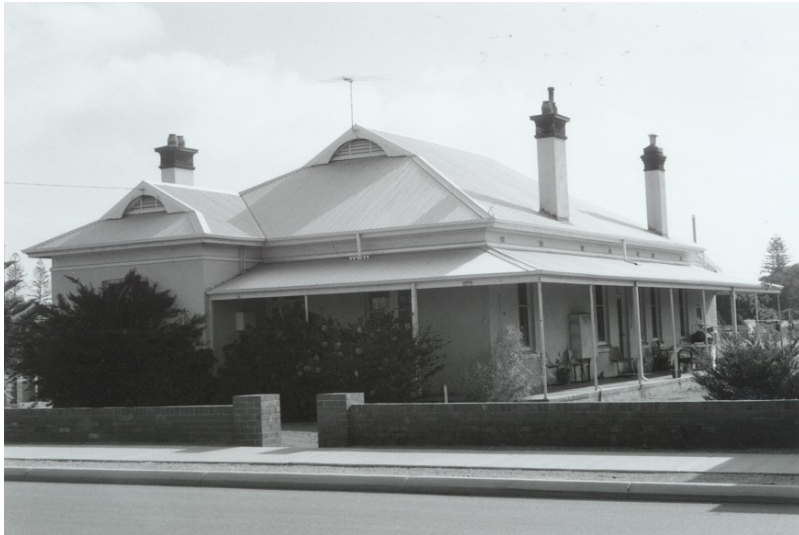
Photo Description:

Walls:	Rendered Masonry	Roof:	Corrugated Iron
Condition:	Not applicable	Integrity:	
Original fabric:			
Modifications:	One chimney removed

Chimney to left since removed.
