Area: Geraldton	Place Number: 85	Category: 3
Assessment Date: 25/10/1996	Last Revision Date: 27/10/2009	
HCWA Number: 13340	Asset ID: MCH126489

Name:	House
Other Names:	16 Conway Street
Type of Place:	House
Address:	16 Conway Street
Suburb:	Beachlands

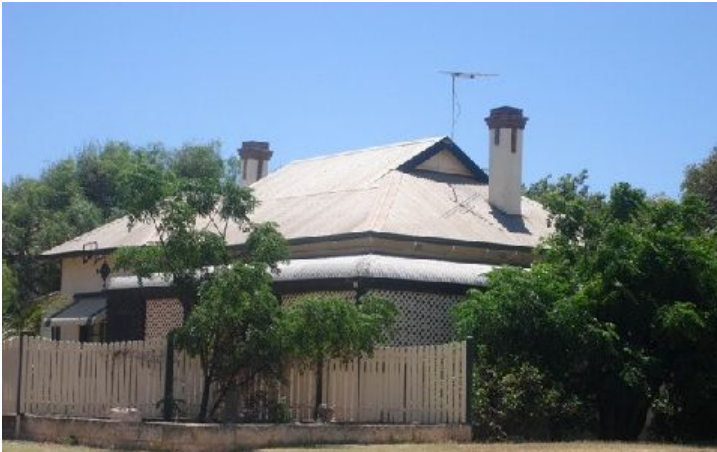
Photo Description:

The bull nose verandah addresses two sides of the house.

This stucco rendered brick house has a corrugated iron gambrel roof with a hipped roof to the main room. A separate bull nose verandah supported on timber posts has trellis infill. The main room has a decorative diamond shaped feature above the aluminium awning which shades the centrally placed window. Windows are casement style. There are two tall rendered brick chimneys to the west and east. A fibro lean-to has been added to the west side. A timber picket fence forms the property frontage.

Management Category: 3
Level of Significance: MODERATE SIGNIFICANCE: Important to the heritage of the locality.
Management Recommendation: Conservation of the place is recommended. Any proposed change to the place should not unduly impact on the heritage values of the place and should retain significant fabric wherever feasible.

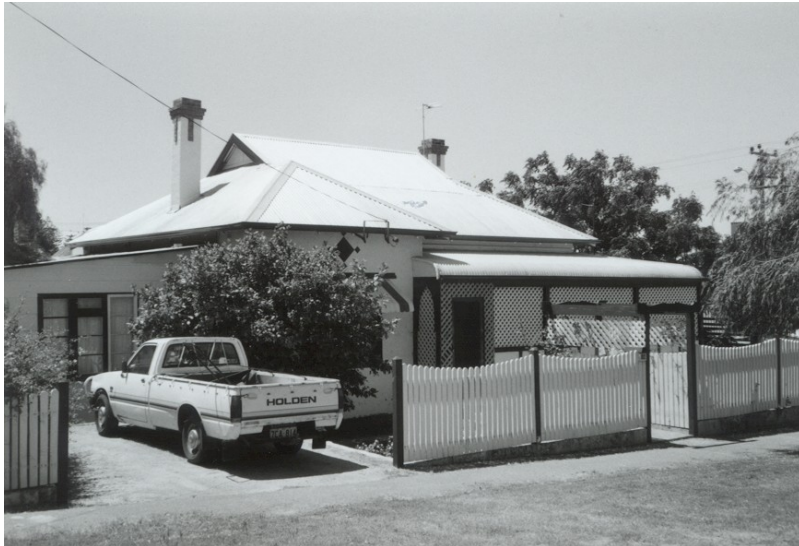
Photo Description:

Two chimneys punctuate the roof scape.
