Area: Geraldton	Place Number: 384	Category: 3
Assessment Date: 03/12/1996	Last Revision Date: 15/03/2010	
HCWA Number: 13779	Asset ID: MCH126617

Name:	House
Other Names:	10 Snowdon Street
Type of Place:	House
Address:	10 Snowdon Street
Suburb:	Geraldton

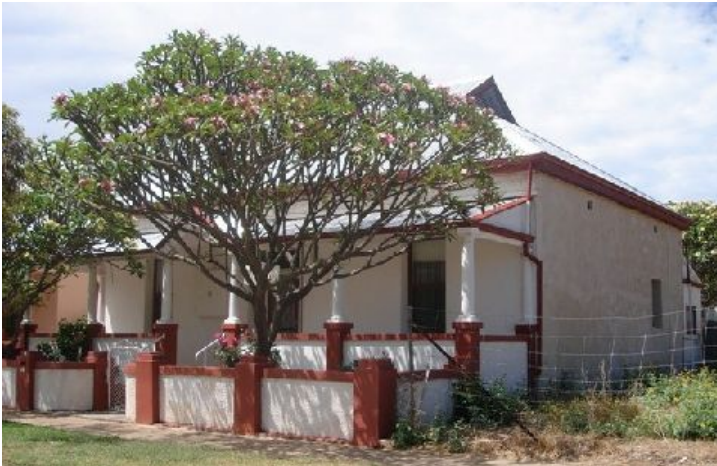
Verandah columns have replaced original posts.

Walls:	Stone (Rendered)	Roof:	Corrugated Iron
Condition:	Good	Integrity:	
Original fabric:			
Modifications:	Large extension to rear

This stone house has a render finish and a steeply pitched corrugated iron gambrel roof. The separate verandah roof to the front is supported on masonry columns and has a masonry balustrade. A small gable to the verandah enhances the main entrance. Windows are double hung and timber framed. To the rear, there is a lean-to section and a rendered corbelled chimney. A low rendered masonry wall forms the front boundary and matches the style of the balustrade.

Management Category:	3
Level of Significance:	MODERATE SIGNIFICANCE: Important to the heritage of the locality.
Management Recommendation:	Conservation of the place is recommended. Any proposed change to the place should not unduly impact on the heritage values of the place and should retain significant fabric wherever feasible.
