Area: Geraldton	Place Number: 389	Category: 3
Assessment Date: 03/12/1996	Last Revision Date: 15/03/2010	
HCWA Number: 13783	Asset ID: MCH126639

Name:	House
Other Names:	21 Snowdon Street
Type of Place:	House
Address:	21 Snowdon Street
Suburb:	Geraldton

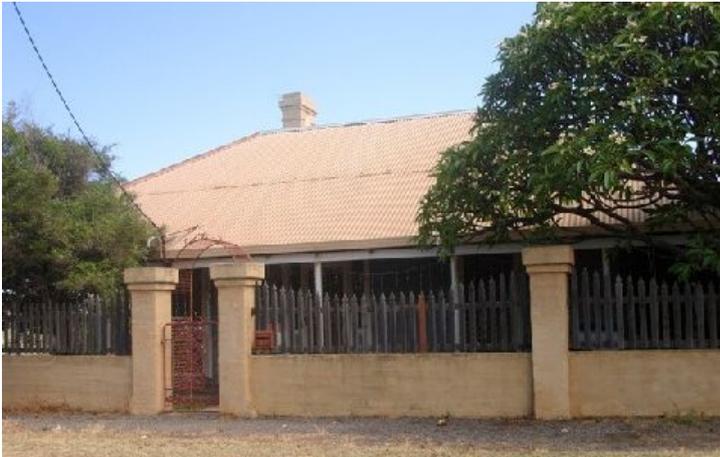
Front facade from Snowdon Street.

Walls:	Weatherboard/Fibro	Roof:	Corrugated Iron
Condition:	Fair	Integrity:	
Original fabric:			
Modifications:

This timber framed house is clad with weatherboard and fibro sheeting. The hipped corrugated iron roof extends to cover the verandahs to the front and east elevations which are supported on metal posts. The south and east elevations feature french doors to the verandahs with aluminium framed windows to the west. To the rear there is a lean-to roof and a tall corbelled rendered brick chimney. A low rendered wall with brick piers and timber picket infill forms the street boundary.

Management Category:	3
Level of Significance:	MODERATE SIGNIFICANCE: Important to the heritage of the locality.
Management Recommendation:	Conservation of the place is recommended. Any proposed change to the place should not unduly impact on the heritage values of the place and should retain significant fabric wherever feasible.

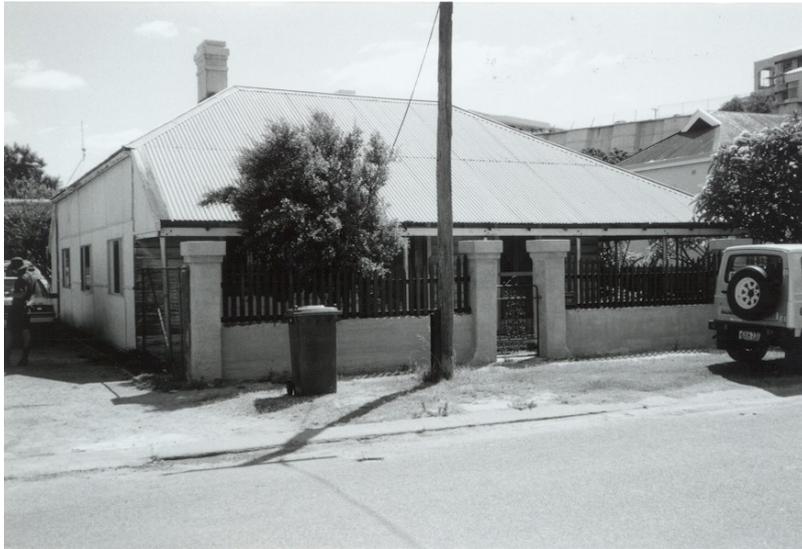
This house still retains much of its original fabric including its tall corbelled chimney and long roof line and as such it makes a contribution to the streetscape of the area.

A tall corbelled chimney punctuates the roofscape.
