# Bushfire Consulting Bushfire Management Statement

Project No22144 V3

Lot 15 379 Red Emperor Drive  
South Greenough

PROPERTY DESCRIPTION	
Address of Development	Lot 15 – 379 Red Emperor Drive South Greenough
Local Government Area	City of Greater Geraldton
Proposal	Single Story Ancillary Dwelling
Town Planning Scheme	5

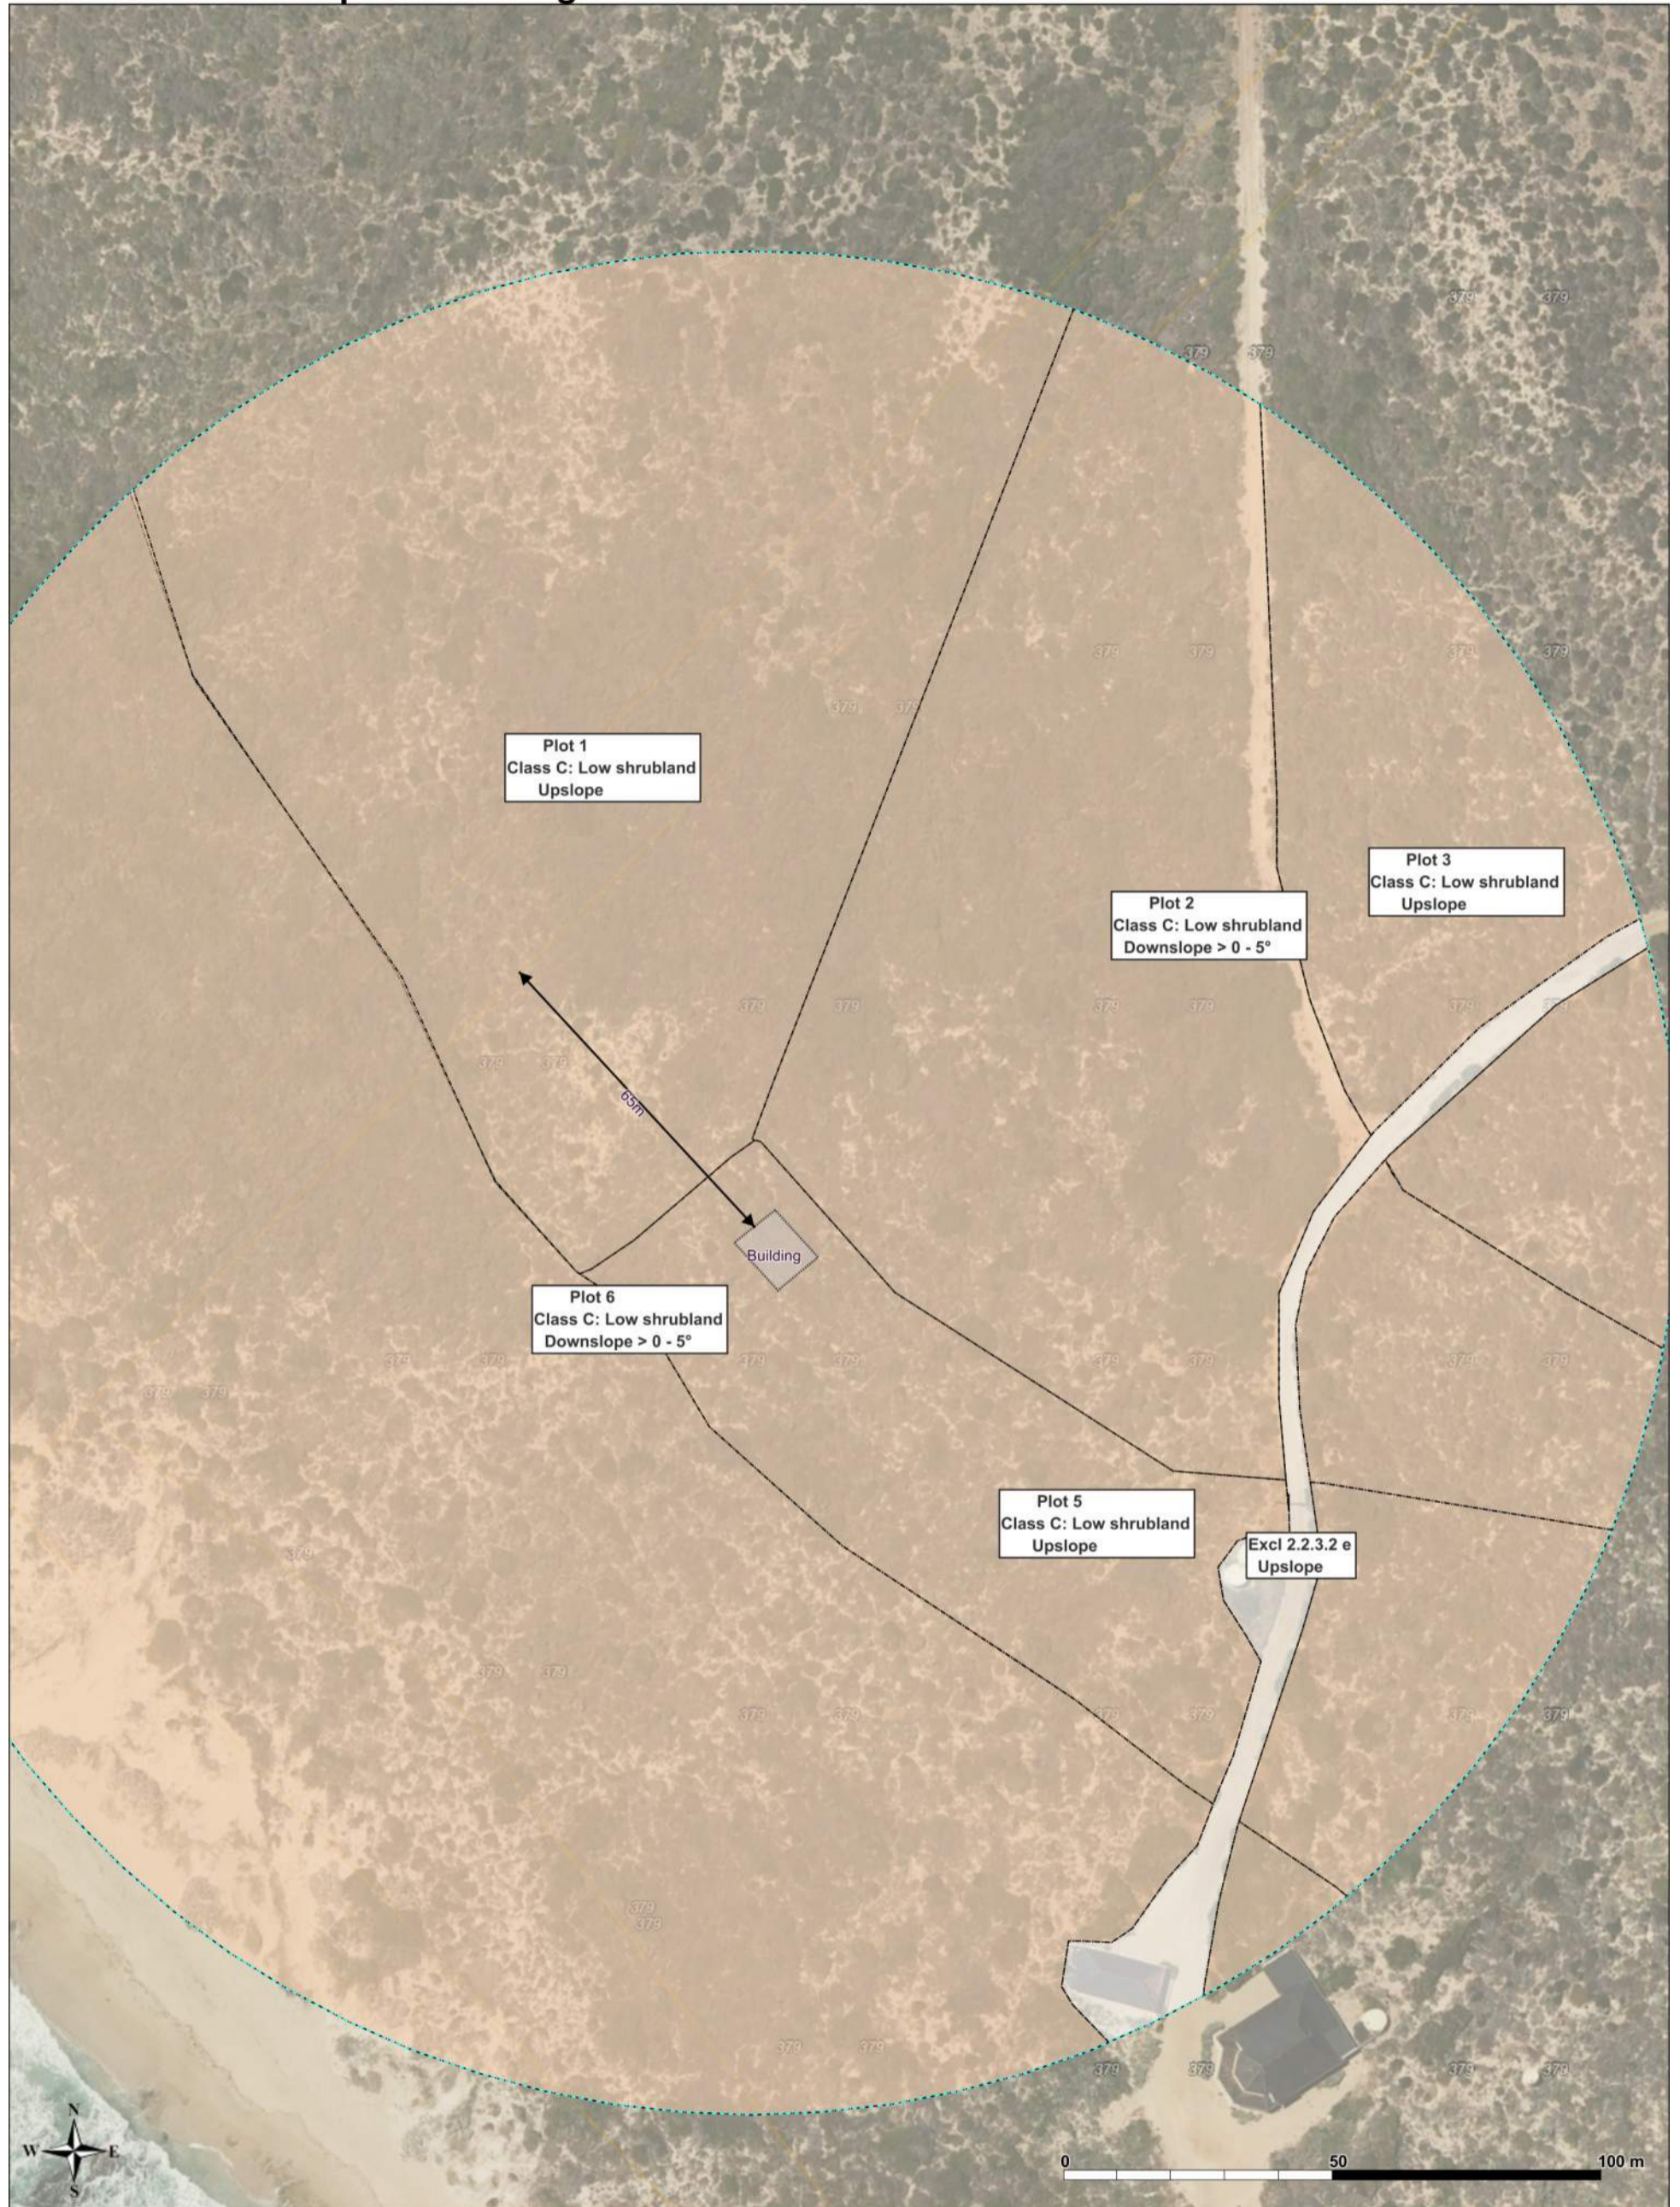
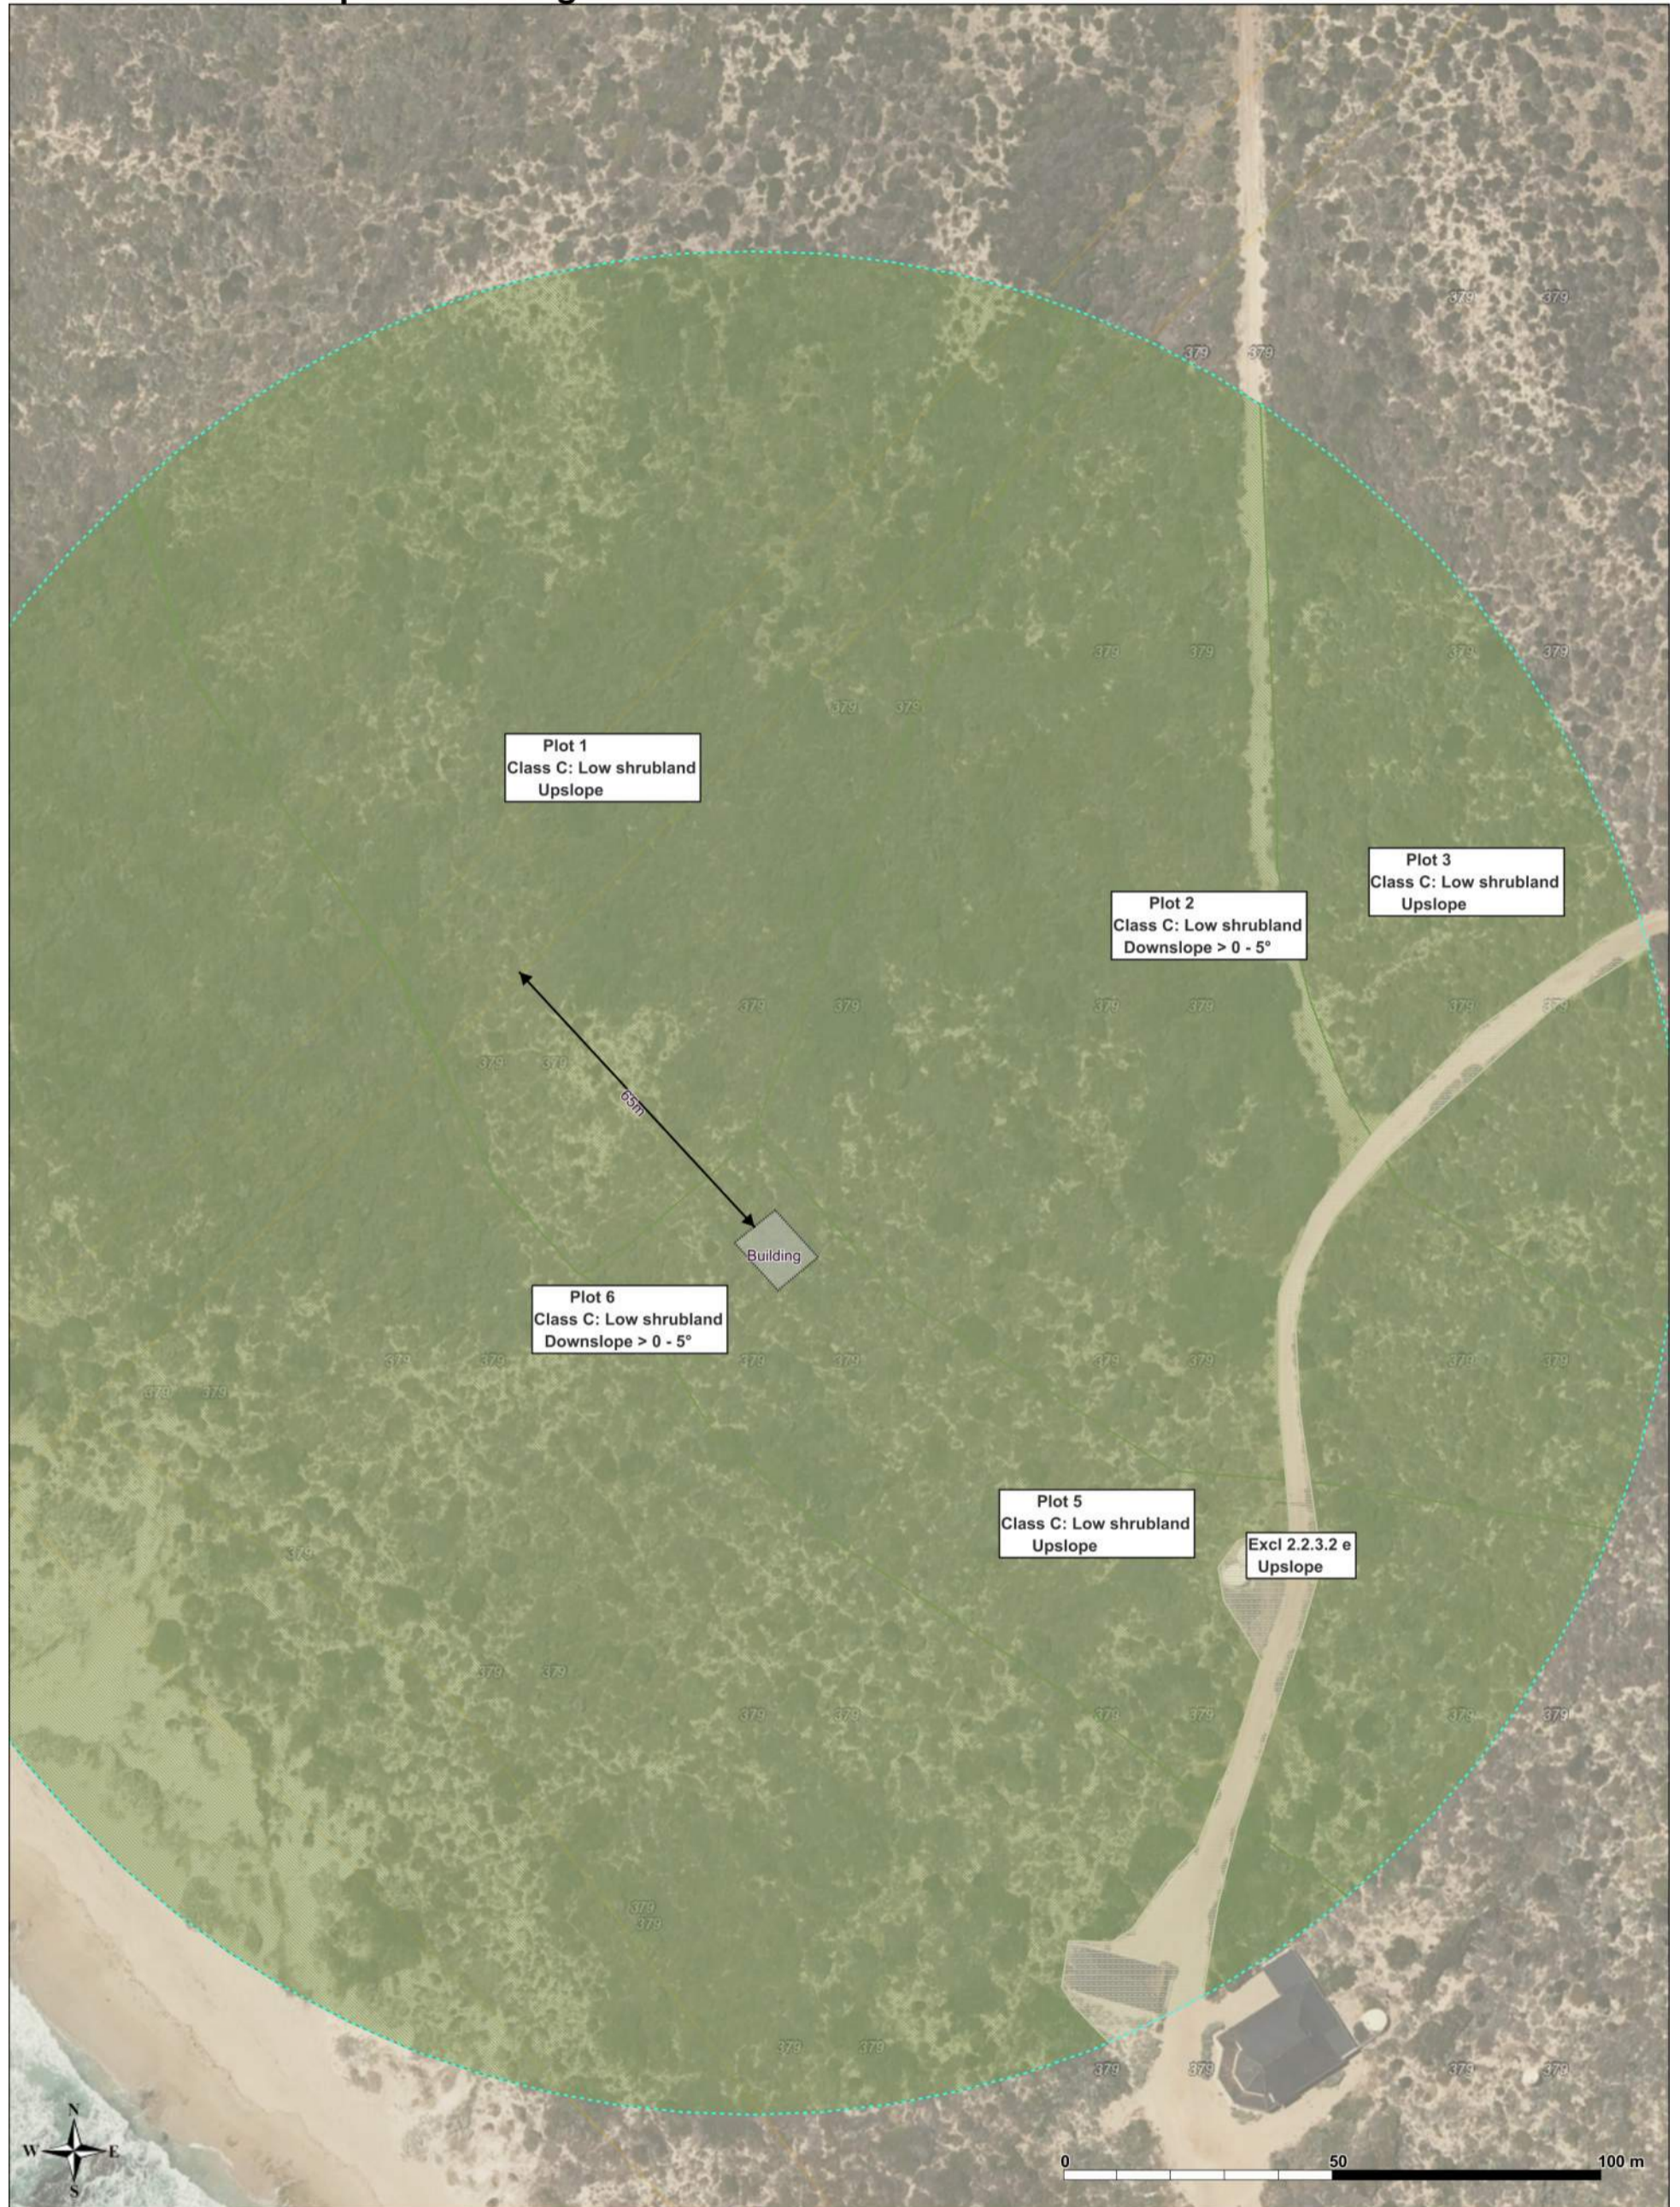
Figure 3 Bushfire Vegetation Classification (A3 Page)

**Dimensions** 150m survey  
**Buildings** Building Location  
**Bushfire Assessment Area** C. Shrubland, 0  
 ← Setback Bushfire Assessment Area 150m C. Shrubland, -5 Excluded, e, 0

**Dimensions** 150m survey  
**Buildings** Building Location  
**Bushfire Assessment Area** C. Shrubland, 0  
 C. Shrubland, -5  
 Excluded, e, 0  
**Setback**  
**Bushfire Assessment Area 150m**

Site plots plan, [Figure 3 Bushfire Vegetation Classification \(A3 Page\)](#) shows all classifiable vegetation within 150m of the allotment boundaries. [Figure 4 Bushfire Assessment Map \(A3 Page\)](#) also shows all exclusions considered under AS 3959 Clause 2.2.3.2. The inputs are to identify the vegetation classification and hazard for justification for the proposed development. Onsite assessment and data collection has taken place and clarifies the results in [Table 1 Hazard Level Table](#) and [Table 2 Bushfire Attack Level Output on Proposed Development – BAL](#).

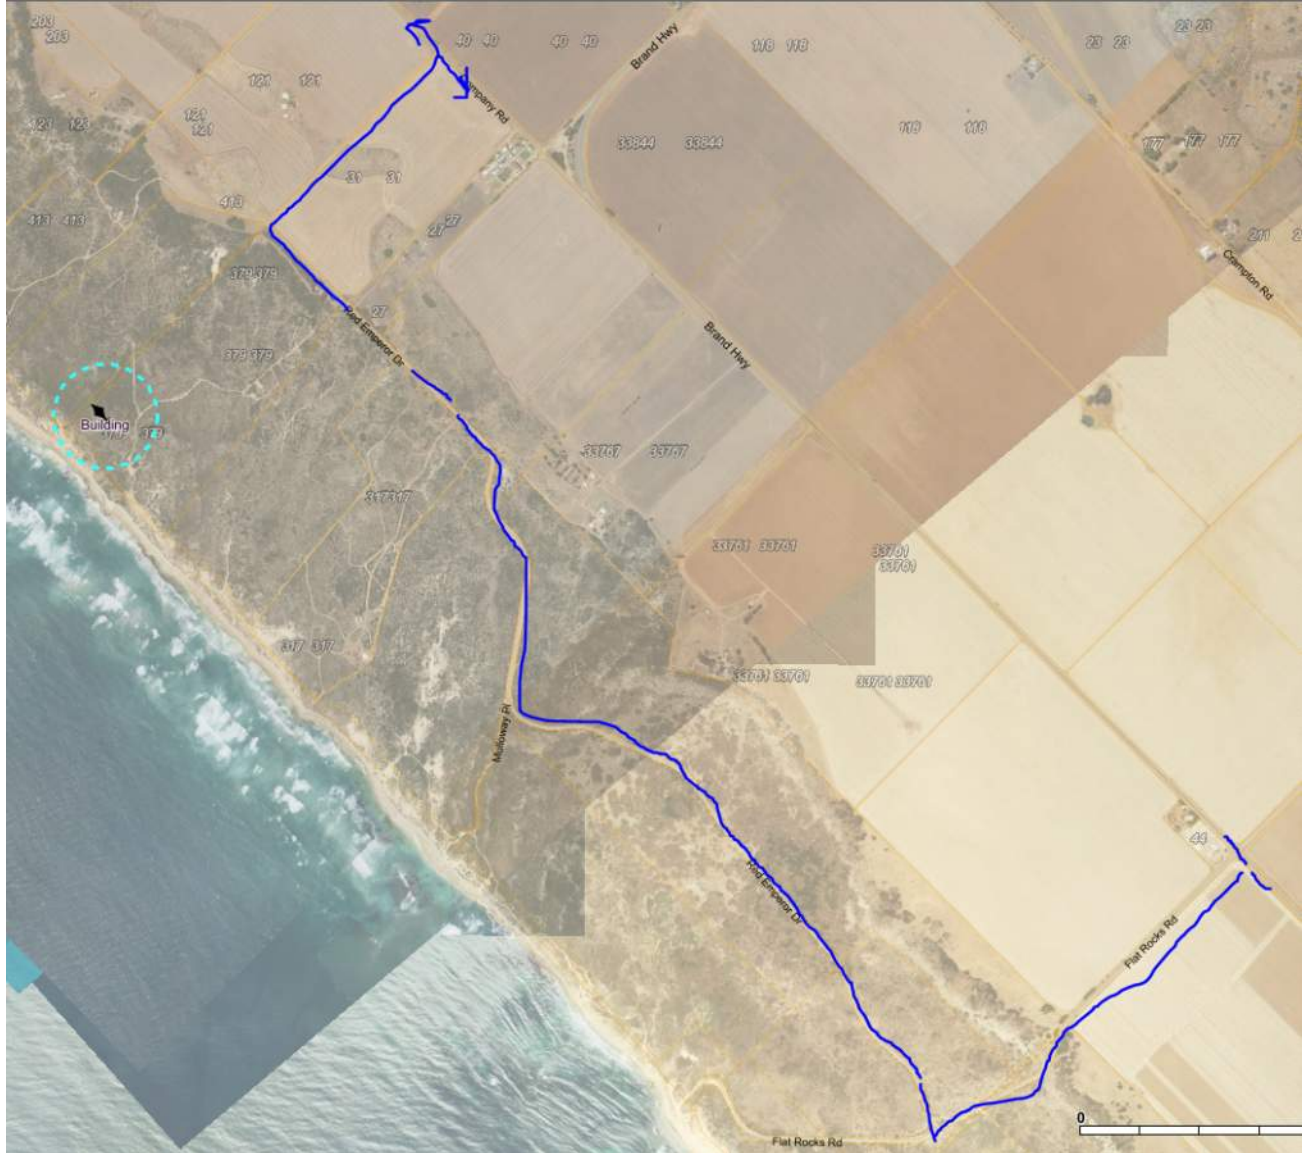
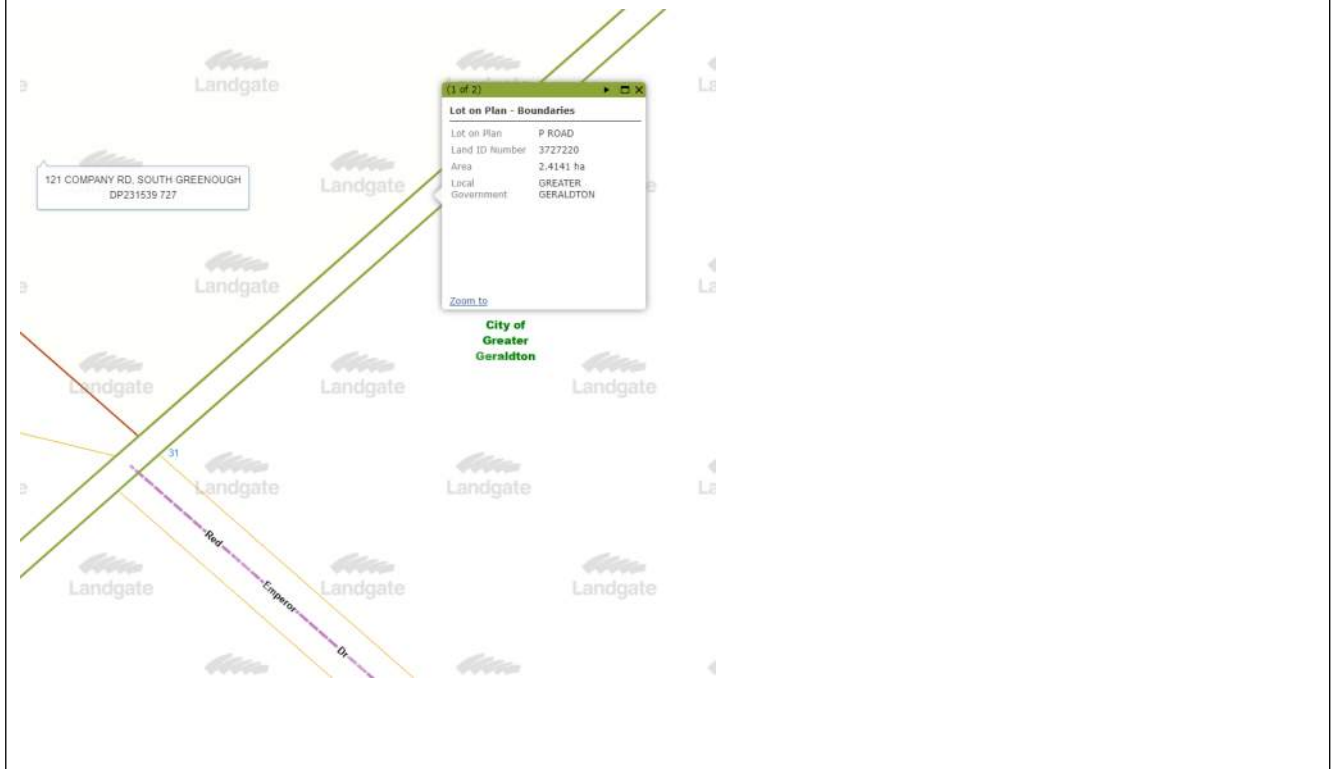
The property entry fronts onto Red Emperor Drive. Red Emperor Drive is and constructed gravel road that leads to Company Road to the North and Flat Rocks Road to the South. Both Company and Flat Rocks Road are sealed roads. Appendix 1 photos 47 & 48 show the existing Land ID 3727220 access road for emergency. Photo 45 shows the constructed road heading south on Red Emperor Drive.

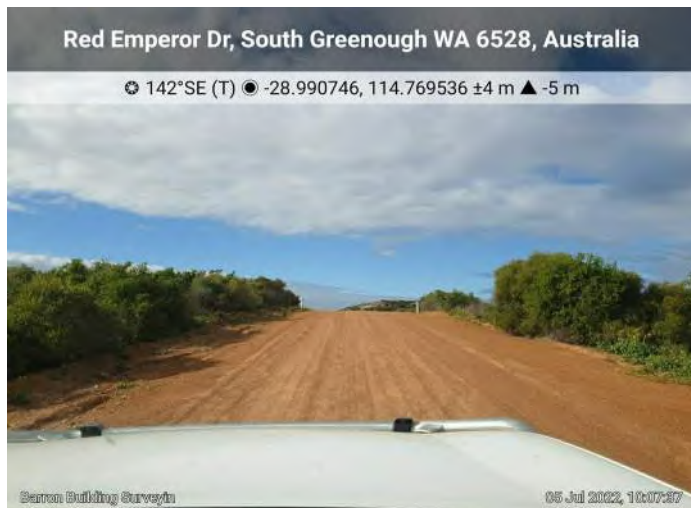
## 45 - Red Emperor Road

ELEMENT 3: VEHICULAR ACCESS	
PERFORMANCE PRINCIPLE	PROPOSED ACCEPTABLE SOLUTIONS
P3i	A3.1 Public roads
STATEMENT OF COMPLIANCE	
No public road proposed for this development. Red Emperor Drive is the existing roadway. In Appendix 1 photos 40 and 45 show the road condition. This road is managed under the Local government.

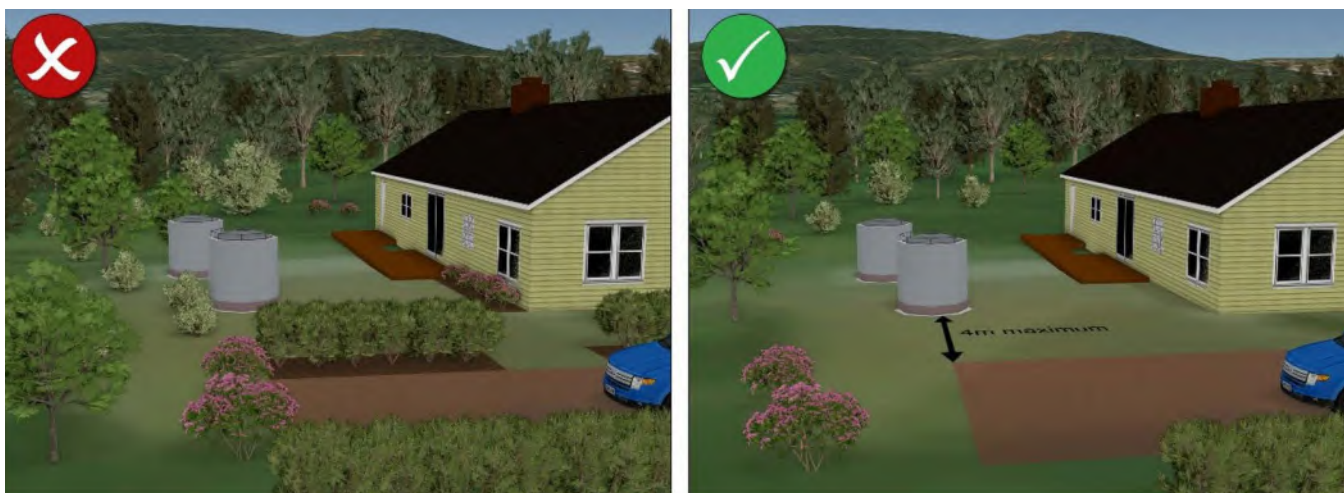
Figure 30: A good and bad example of landscaping around a water tank

A water tank should be located with consideration to surrounding vegetation and should avoid locations where the tank will be situated underneath existing vegetation or where vegetation will grow against or overhang the tank, as shown in Figure 30 below. Where a tank is located on the bushfire hazard side of a building, sufficient shielding for the protection of firefighters should be provided. In addition to the tank location, the fitting should be positioned and/or shielded from the bushfire hazard to allow access by emergency services. It is recommended that the fitting face away from the bushfire hazard and be within four metres of a hardstand area.

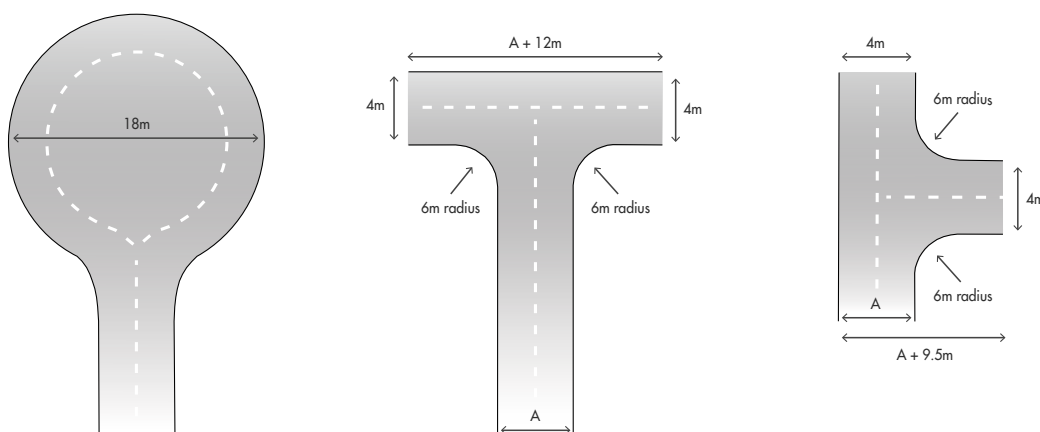
**Figure 28:** Design requirements for a turn-around area for a private driveway or battle-axe

Turnaround areas should be available for both conventional two-wheel drive vehicles of residents and Type 3.4 fire appliances. Turn-around areas should be located within 30 metres of habitable buildings. Circular and loop driveway design may also be considered. Note that the design requirements for a turn-around area for a private driveway or battle-axe differ to a cul-de-sac.

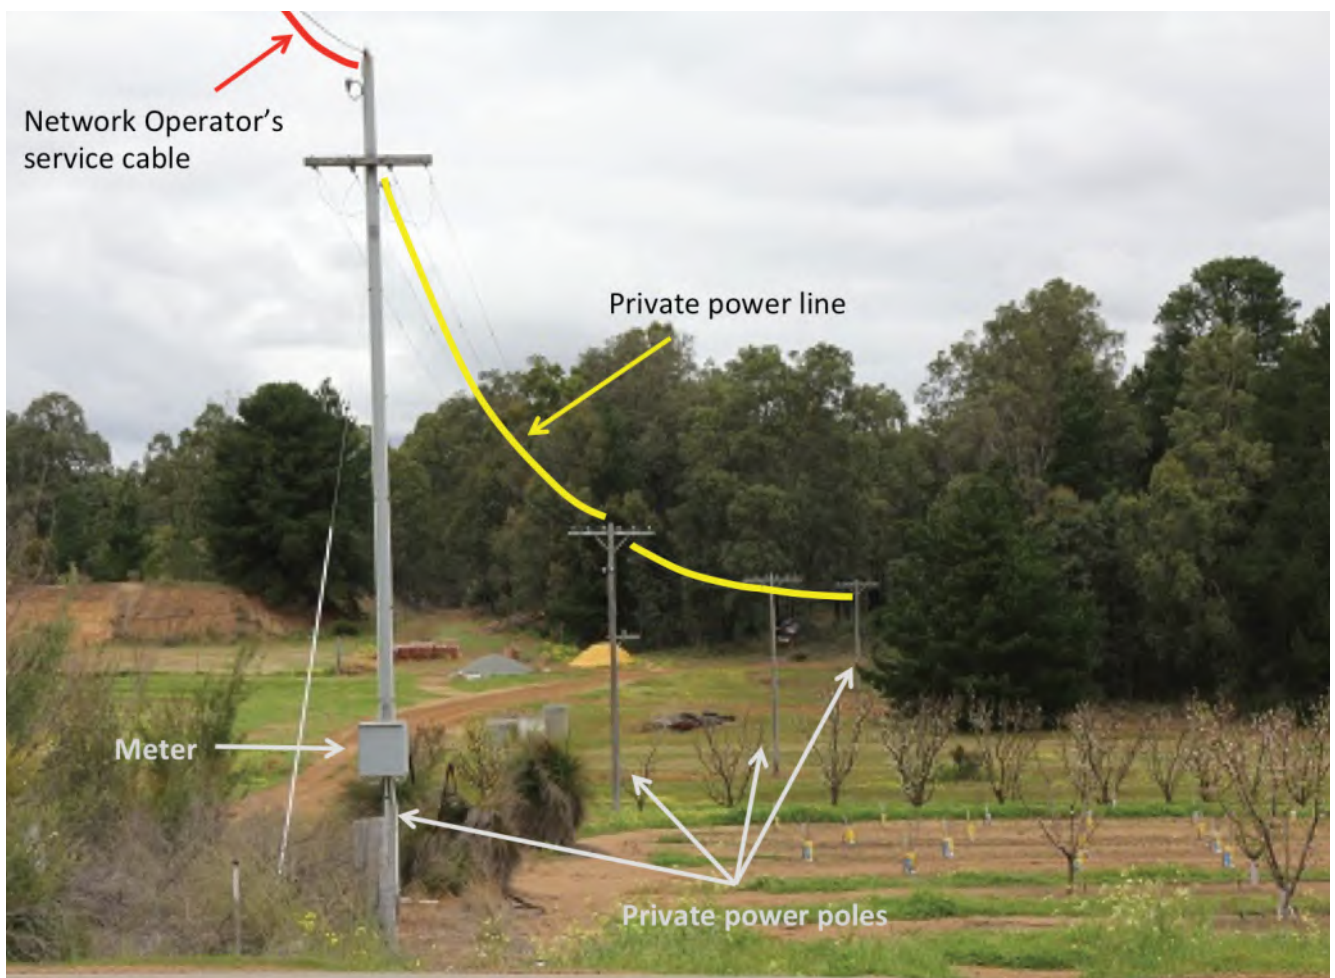
Figure 1 - Typical rural private overhead power line and private poles

Some common private power line arrangements are shown in Figures 1 to 3 (below) and in the Appendix.

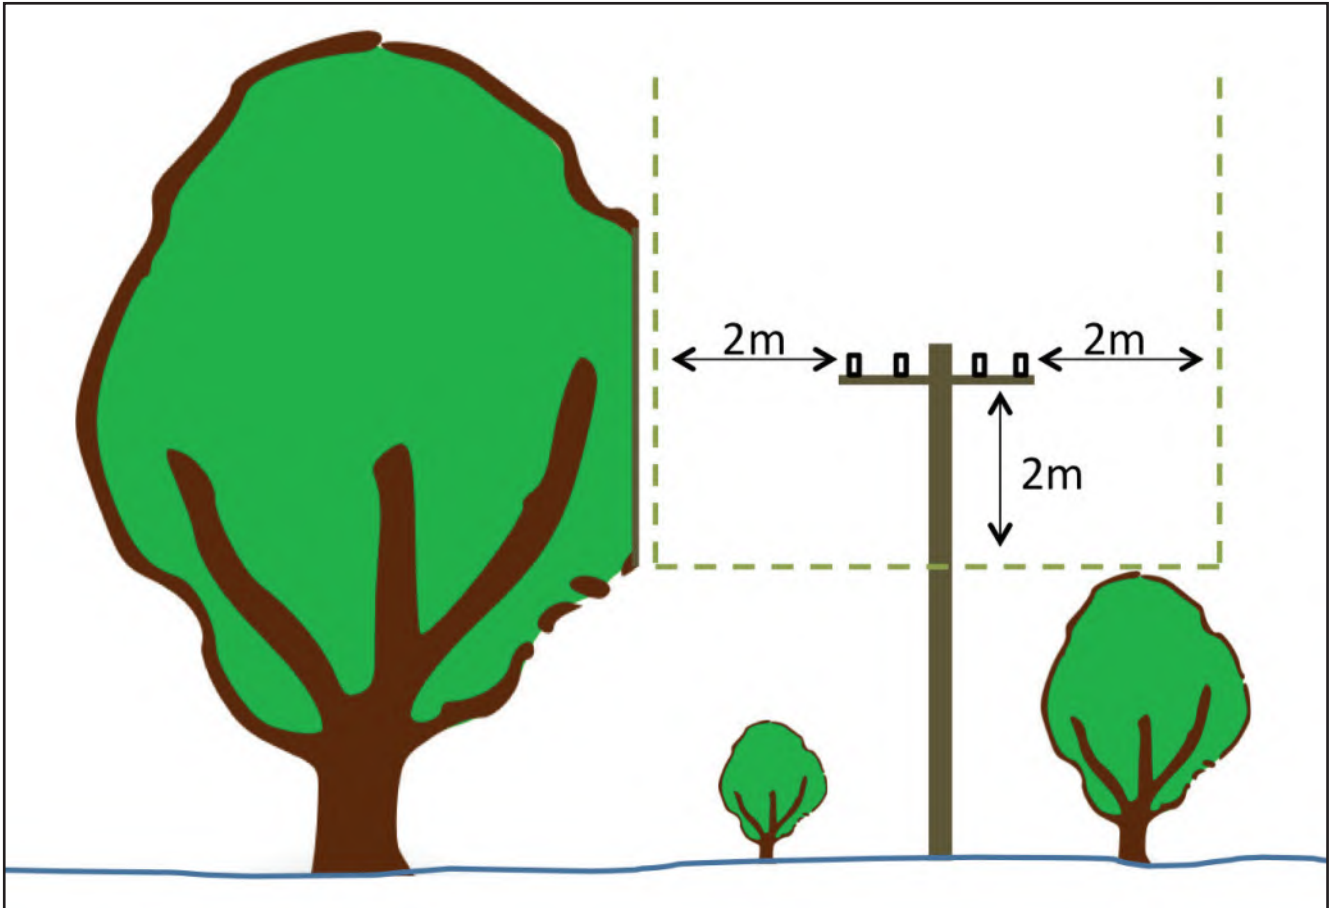
Figure 4 – Vegetation minimum clearance profile

- Trees and branches must be maintained at least two metres away from bare power line conductors (Fig 4). Pruning vegetation within two metres of conductors must be carried out either with the electricity switched off or by using a competent vegetation control service provider<sup>2</sup>.

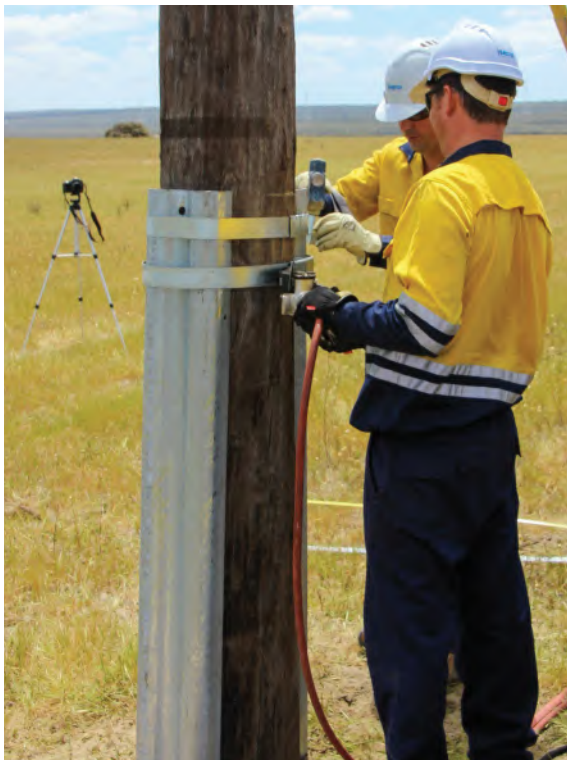
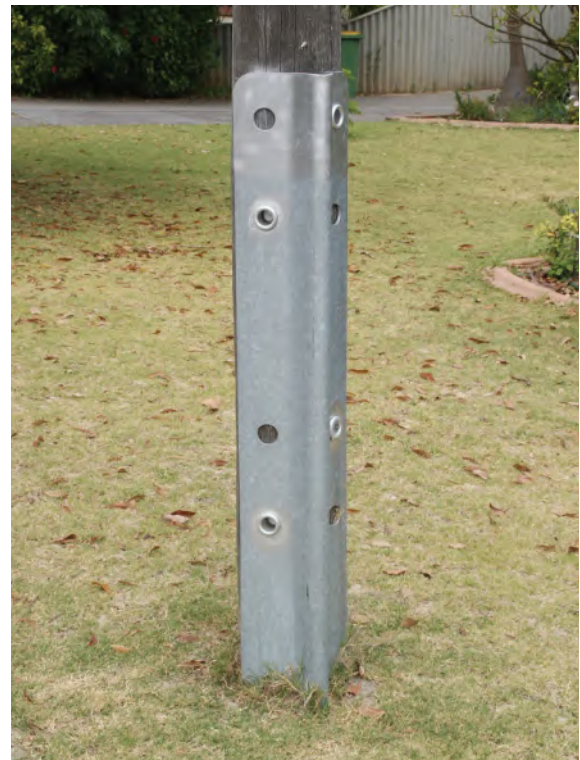
Figure 5 – Typical reinforcement of timber poles with steel supports

- In some cases, ground-line reinforcements using galvanised steel supports can be used to extend the life of wood poles. However, this work must only be performed by asset management companies specialising in such services. Electrical contractors must not attempt to reinforce poles unless they can certify that the reinforced poles satisfy the structural properties prescribed in Appendix D of AS/NZS 3000:2018.

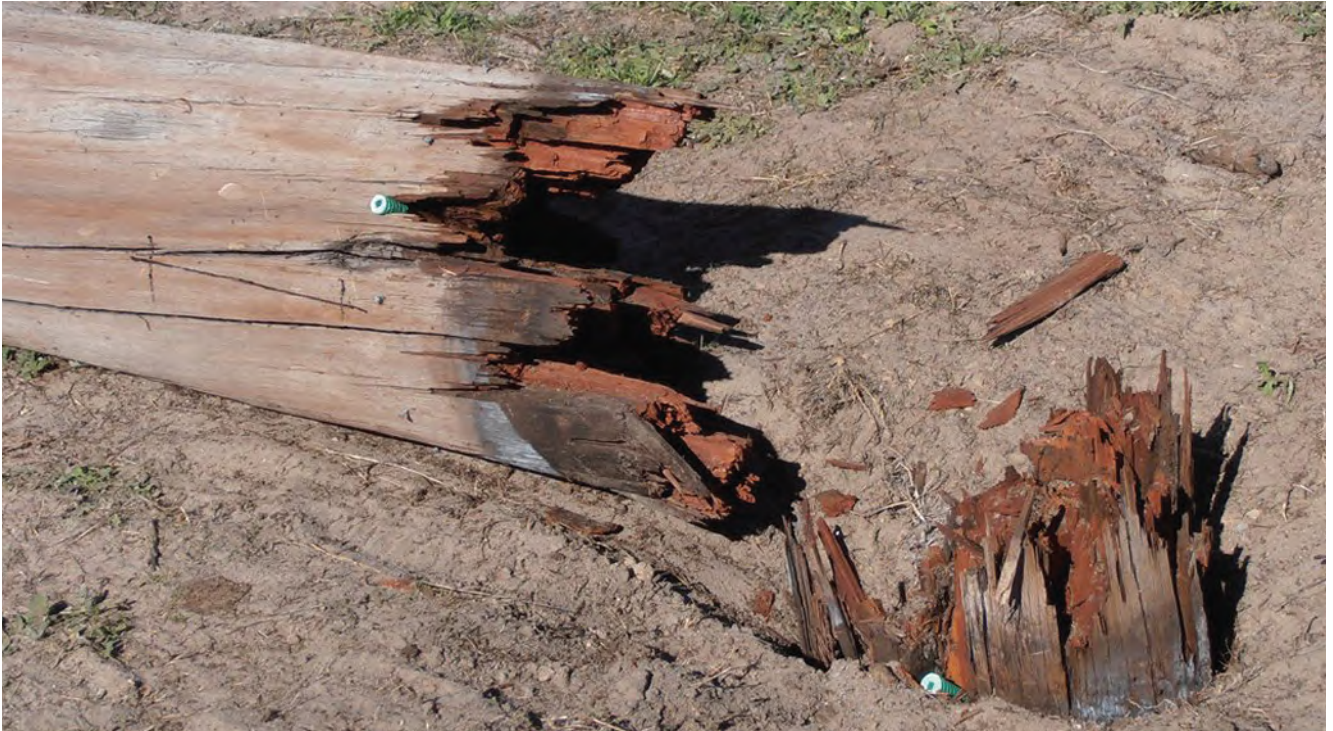
Figure 6 - Complete failure of Jarrah wood pole due to decay/rot at ground line

- The difficulty in assessing the extent of internal deterioration and rotting in wood poles makes age-based replacements the only reliable option.
- If the poles are hardwood such as jarrah and are likely to have been in service for more than 25 years, they should either be replaced or structurally reinforced (where feasible).

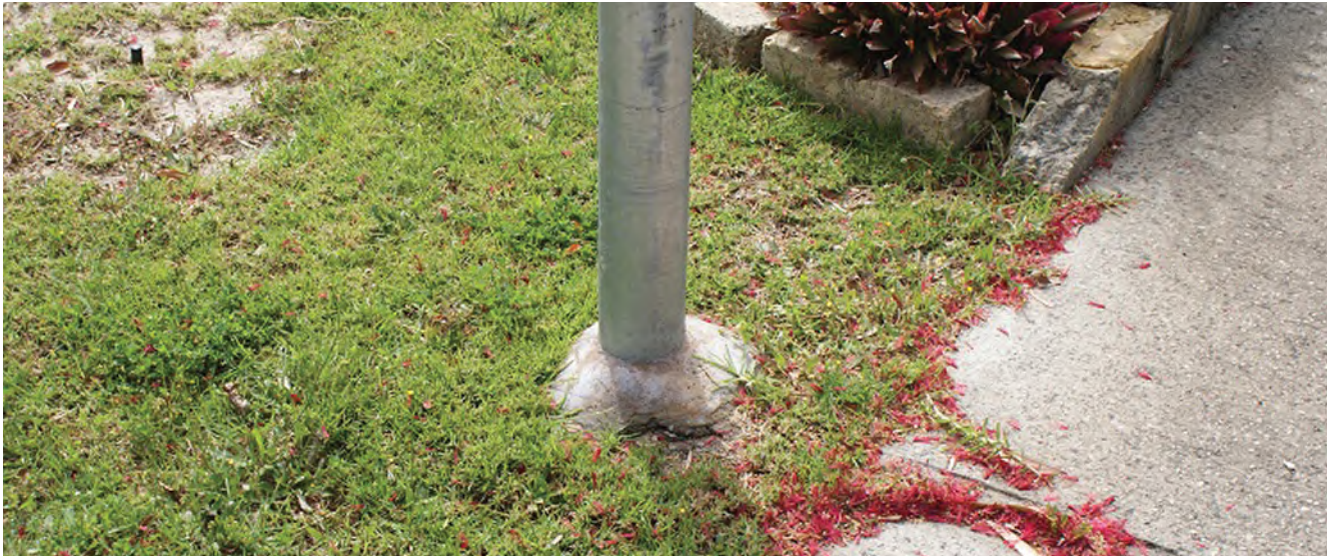
Figure 7 - Correct installation of steel pole with concrete footing finished above ground

- The life expectancy of steel poles is 30 years or more, depending on soil conditions, and provided they are galvanised and have well-constructed concrete footings. The correct installation method is for the footing to be finished at 100mm above ground level and shaped to shed water, as shown in Figure 7 below (refer AS/NZS 3000:2018 Appendix D2 Note 3(b)).
- However, all steel poles are subject to corrosion and should be checked. Where the concrete footing is not above ground level, there is a higher risk of below ground corrosion.

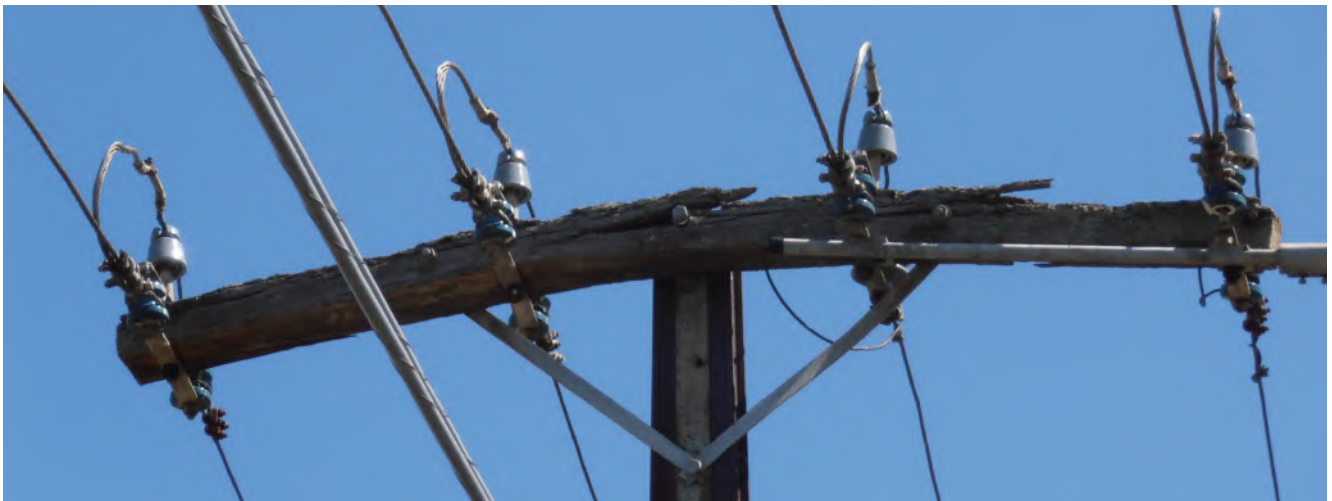
Figure 8 – A badly split low voltage crossarm

Cross-arms should be free from deterioration such as splitting, termite attack or fungal rot.

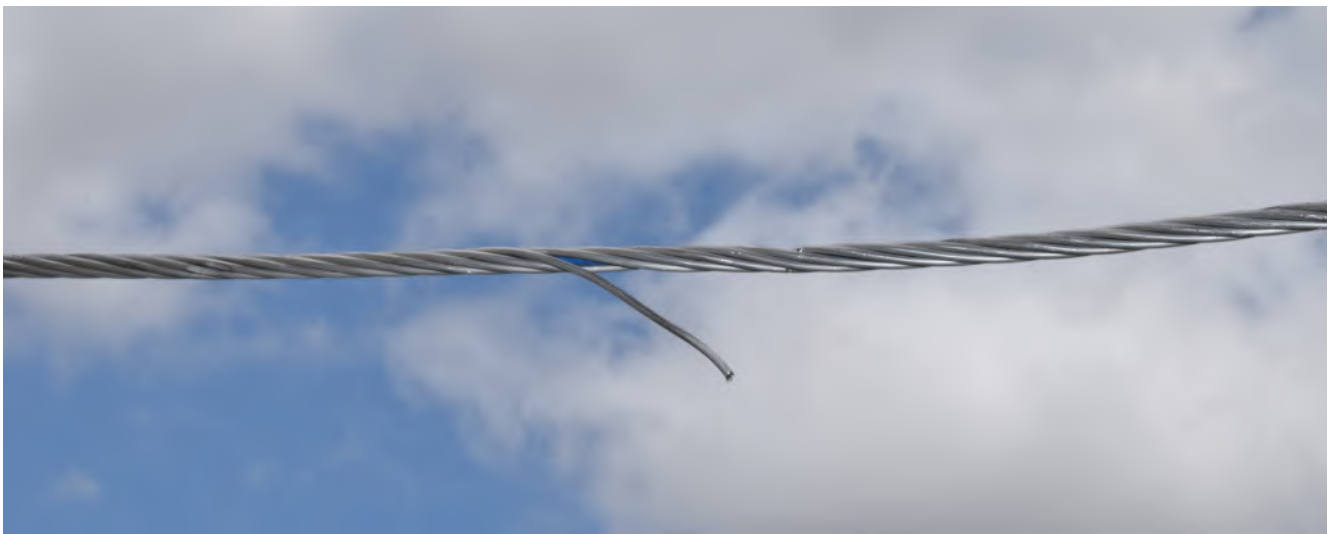
Figure 11 - Broken conductor strand clearly visible

- Deterioration or any visible signs of damage such as:
  - broken wire strands;
  - burn marks caused by clashing conductors or contact with vegetation;
  - severe corrosion and any loss of cross section; and
- if any of the insulation is missing or damaged, the exposed wire may be live. Contact could be fatal, and vegetation touching the bare conductor is more likely to start a fire. Damaged insulated conductors should be replaced, not repaired, so that the safety of the installation is not compromised.

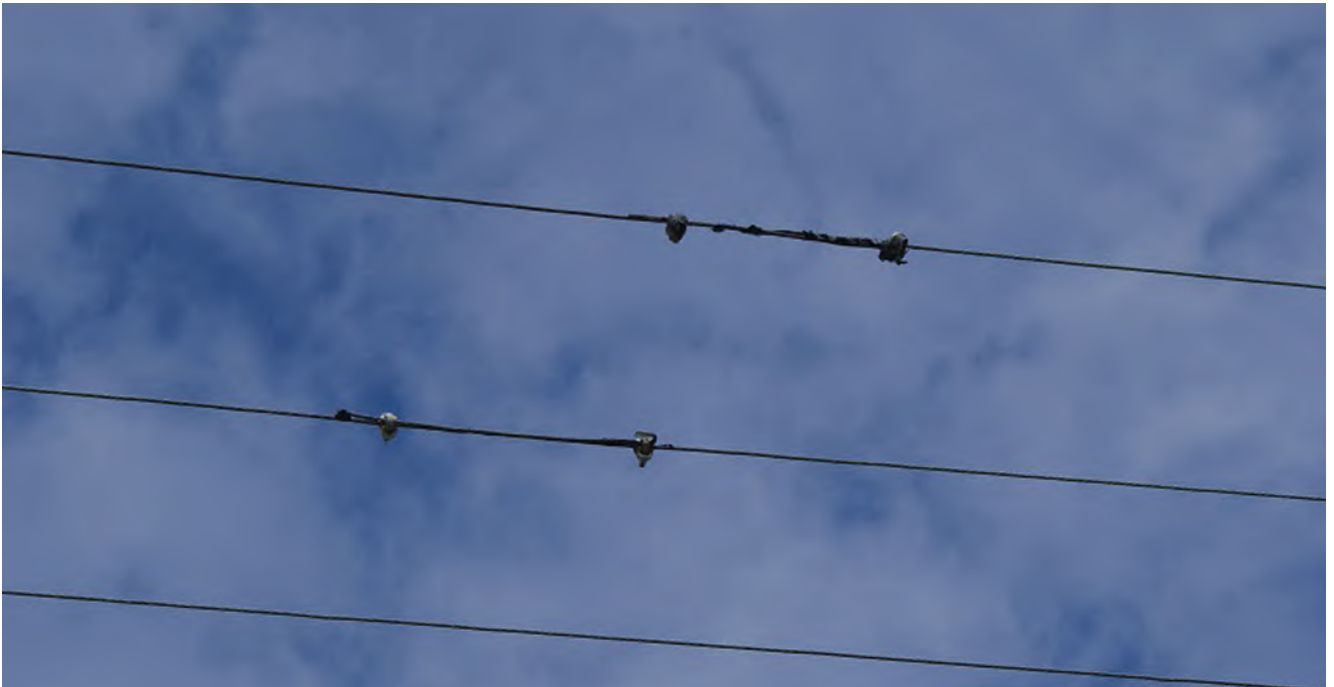
Figure 12 - Example of aged conductor joints and ongoing safety risk

- All electrical connections and joints must comply with Clause 3.7 of AS/NZS 3000:2018.
- Any defective metallic preformed terminations ('twisties') on insulated service leads must be replaced.
- Damaged or corroded mains connection boxes should be repaired or replaced.
