Area: Geraldton	Place Number: 356	Category: 2
Assessment Date: 24/10/1996	Last Revision Date: 11/03/2010	
HCWA Number: 13749	Asset ID: MCH126867

Name:	House
Other Names:	108 Sanford Street
Type of Place:	House
Address:	108 Sanford Street
Suburb:	Geraldton

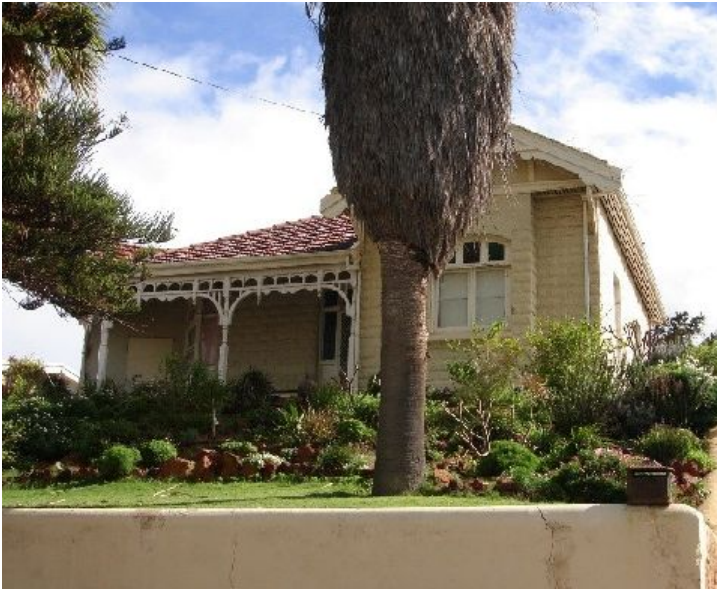
Elevated position and verandah details.

Walls:	Concrete Block	Roof:	Tiled
Condition:	Fair	Integrity:	
Original fabric:			
Modifications:

Set high above the road this concrete block house has a tiled gambrel roof with a separate gable to the front and a small gable roof above the south west corner entry porch. The gable ends have feature bargeboards and brackets. The main tiled roof extends to cover verandahs which have a decorative timber frieze. The street boundary has a low rendered masonry wall. Two palm trees are a feature of the front garden.

Management Category:	2
Level of Significance:	CONSIDERABLE SIGNIFICANCE: Very important to the heritage of the locality.
Management Recommendation:	Conservation of the place is highly recommended. Any proposed change should not unduly impact on the heritage values of the place and should retain significant fabric wherever feasible.

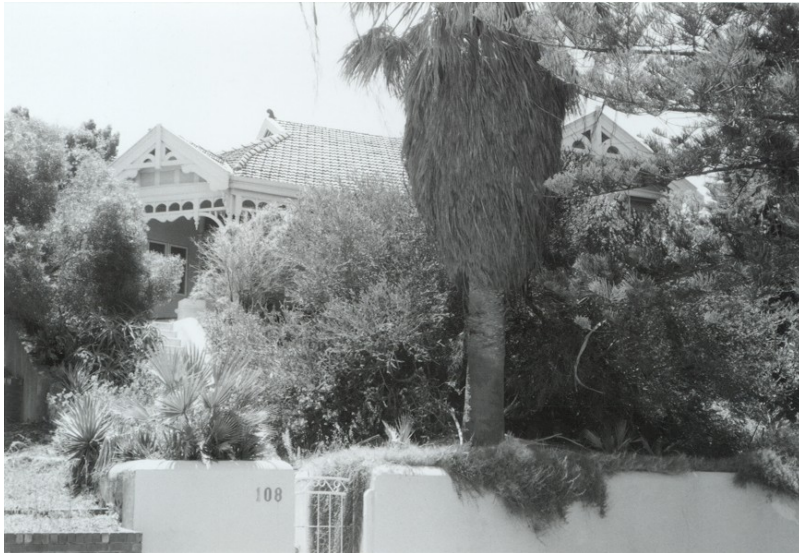
View partly obscured by vegetation.
