Area: Geraldton	Place Number: 366	Category: 3
Assessment Date: 24/10/1996	Last Revision Date: 12/03/2010	
HCWA Number: 13760	Asset ID: MCH126530

Name:	House
Other Names:	109 Shenton Street
Type of Place:	House
Address:	109 Shenton Street
Suburb:	Geraldton

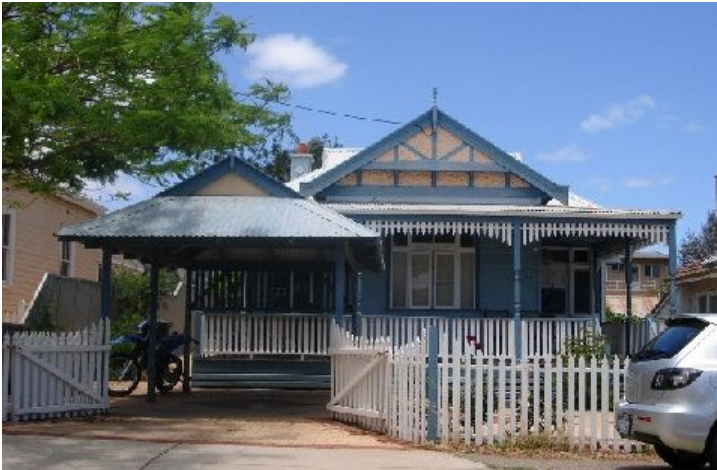
Front facade showing gable end decoration.

Walls:	Weatherboard	Roof:	Corrugated Iron
Condition:	Good	Integrity:	
Original fabric:			
Modifications:

This timber framed weatherboard clad cottage has a gambrel roof with a gable roof to the front which is surrounded on three sides by a separate hipped verandah roof. The gable end has roughcast and timber batten infill with a small finial and pendant. The verandah is supported on turned timber posts and has a timber balustrade and decorative timber frieze. The verandah is accessed via a set of balustraded timber steps. Windows are timber framed and casement style to the front room, double hung with curved metal awnings to the side. There is a gambrel roof carport to the front garden and a picket fence with a small timber porch forms the street boundary of the place.

Management Category: 3
Level of Significance: MODERATE SIGNIFICANCE: Important to the heritage of the locality.
Management Recommendation: Conservation of the place is recommended. Any proposed change to the place should not unduly impact on the heritage values of the place and should retain significant fabric wherever feasible.

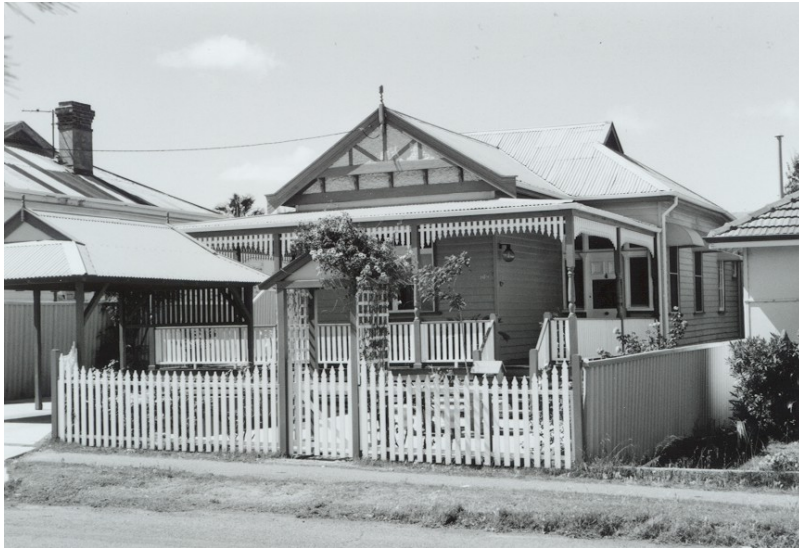
Front facade showing verandah details.
