<b>Area:</b> Geraldton	<b>Place Number:</b> 369	<b>Category:</b> 4
<b>Assessment Date:</b> 24/10/1996	<b>Last Revision Date:</b> 12/03/2010	
<b>HCWA Number:</b> 13763	<b>Asset ID:</b> MCH126541

<b>Name:</b>	House
<b>Other Names:</b>	136 Shenton Street
<b>Type of Place:</b>	House
<b>Address:</b>	136 Shenton Street
<b>Suburb:</b>	Beachlands

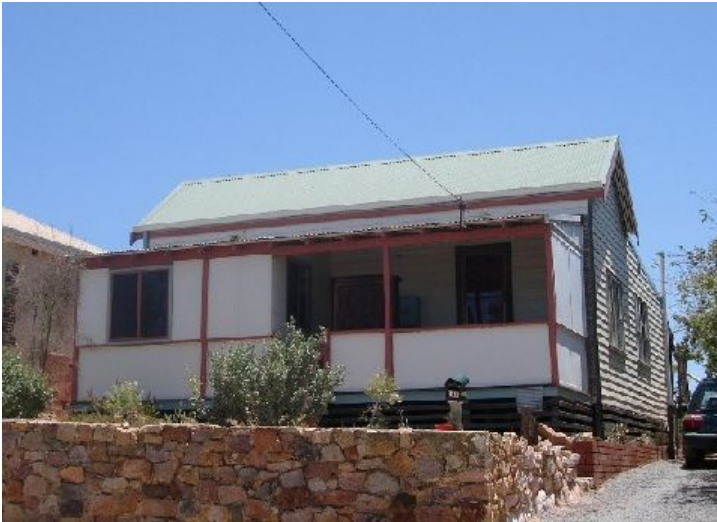
15/01/2008

Front verandah partly enclosed

This small timber framed weatherboard clad cottage has a gable corrugated iron roof with a skillion roof to the rear and a separate verandah roof to the front. The front verandah is supported on timber posts with a fibro balustrade to one half and fibro infill to the other and the verandah ends. The verandah is accessed via timber steps with timber handrails. The property has a stone wall to the front boundary.

<b>Management Category:</b>	4
<b>Level of Significance:</b>	SOME SIGNIFICANCE: Contributes to the heritage and/or historical development of the locality.
<b>Management Recommendation:</b>	Conservation of the place is desirable. Any proposed change to the place should be in sympathy with the heritage values of the place.

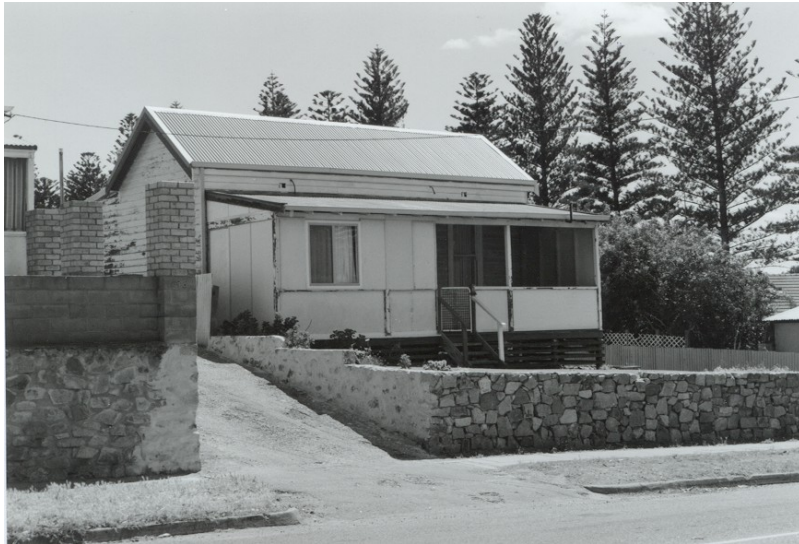
24/10/1996

Small, simple form.
