Area: Greenough	Place Number: 19	Category: 2
Assessment Date: 12/11/1997	Last Revision Date: 24/02/2015	
HCWA Number: 3724	Asset ID: MCH126760

Name:	Rose Cottage
Other Names:	off Phillips Road (south side)
Type of Place:	Cottage
Address:	off Phillips Road (south side)
Suburb:	Greenough

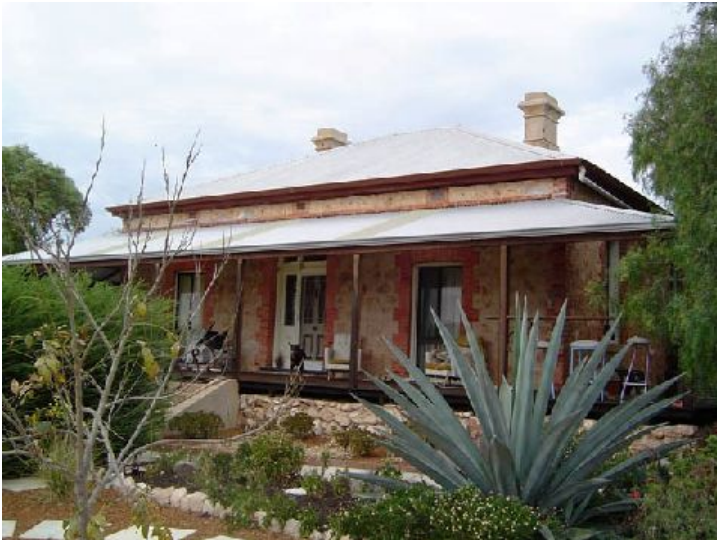
Photo Description:
9/12/2004
Henkel
Front (east) elevation

Located at the end of Phillips Road on the west side of the Greenough River, Rose Cottage is a four-roomed stone house with a hipped corrugated iron roof. Evidence remains of a separate verandah roof to the front facade which has been removed, while the verandah to the south elevation remains intact, although in poor condition. The building features brick quoining to corners and openings and the front facade is enhanced by pointed stonework. Two rendered and moulded chimneys punctuate the roof; the curved moulding being similar to the chimney on Kelly's Cottage [Place No. 7]. The original french doors located either side of the central doorway have been replaced by full length aluminium framed windows. Entry steps featuring decorative rendered columns lead up to the doorway, via the removed verandah. There is a brick and fibro lean-to at the rear.

2004/04 Review: In recent years considerable work has been carried out to the building including the reinstatement of the verandah roof and floor to the east and south elevations.

Management Category:	2
Level of Significance:	CONSIDERABLE SIGNIFICANCE: Very important to the heritage of the locality.
Management Recommendation:	Conservation of the place is highly recommended. Any proposed change should not unduly impact on the heritage values of the place and should retain significant fabric wherever feasible.
