Area: Greenough	Place Number: 193	Category: 4
Assessment Date: 12/11/1997	Last Revision Date: 24/02/2015	
HCWA Number: 3747	Asset ID: MCH126721

Name:	Connolly Cottage
Other Names:	Crampton Road (west side)
Type of Place:	Cottage
Address:	Crampton Road (west side)
Suburb:	South Greenough

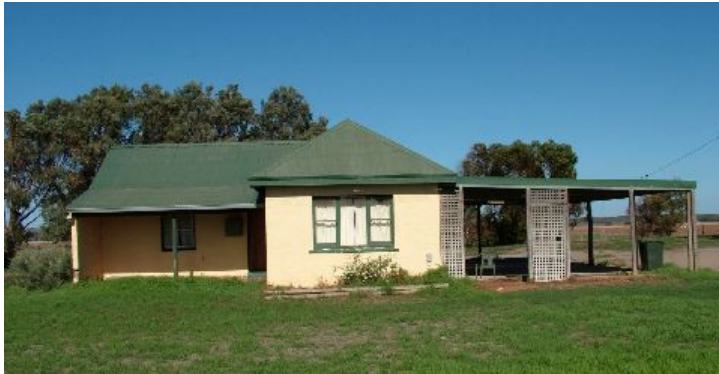
Photo Description:

Walls:	Limestone/Concrete	Roof:	Corrugated Iron
Condition:	Good	Integrity:	
Original fabric:			
Modifications:

The original rendered stone cottage has a gable corrugated iron roof which extends broken back to cover the front verandah. A concrete block extension with a hipped iron roof has been added to the north-east corner while a large patio is attached to the north elevation. To the south of the cottage is the site of the stone barn which was demolished c1995.

Management Category:	4
Level of Significance:	SOME SIGNIFICANCE: Contributes to the heritage and/or historical development of the locality.
Management Recommendation:	Conservation of the place is desirable. Any proposed change to the place should be in sympathy with the heritage values of the place.
