<b>Area:</b> Greenough	<b>Place Number:</b> 223	<b>Category:</b> 4
<b>Assessment Date:</b> 09/12/2005	<b>Last Revision Date:</b> 15/03/2010	
<b>HCWA Number:</b> 13776	<b>Asset ID:</b> MCH126842

<b>Name:</b>	Cottage ruin
<b>Other Names:</b>	Geraldton-Mount Magnet Road
<b>Type of Place:</b>	Ruin
<b>Address:</b>	Geraldton-Mount Magnet Road
<b>Suburb:</b>	Moonyoonooka

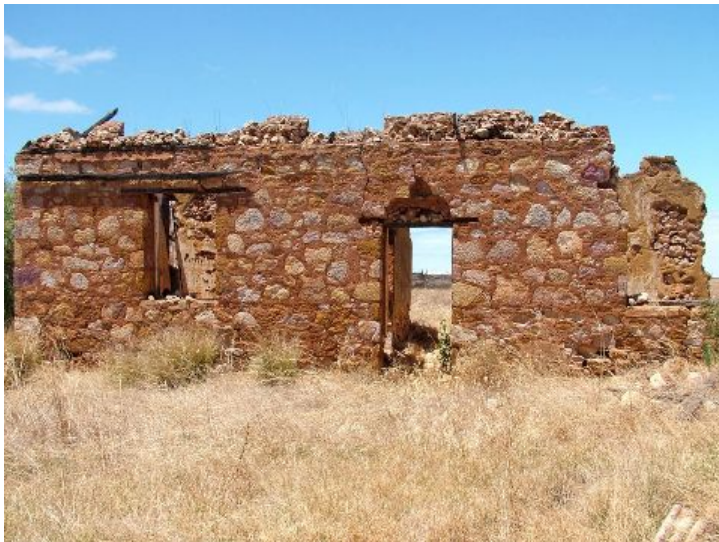
Ruin viewed from the Geraldton-Mount Magnet Road

<b>Walls:</b>	Stone	<b>Roof:</b>	Not applicable
<b>Condition:</b>	Poor	<b>Integrity:</b>	
<b>Original fabric:</b>			
<b>Modifications:</b>

Located just to the south of the Geraldton-Mount Magnet Road are the stone ruins of a cottage. The cottage consisted of 4 rooms with a central passageway. The south and west walls of the cottage have collapsed. Timber work shows signs of fire damage. There is evidence to suggest the cottage had a verandah on the front (north) side and a gable roof.

<b>Management Category:</b>	4
<b>Level of Significance:</b>	SOME SIGNIFICANCE: Contributes to the heritage and/or historical development of the locality.
<b>Management Recommendation:</b>	Conservation of the place is desirable. Any proposed change to the place should be in sympathy with the heritage values of the place.
